PROJECT REQUEST FORM

Project Title KROST LAW EMERGENCY WATER LEAK REPAIRS	
Building # 537	Building Name KROST LAW
Emergency or Immediate Funding* <input checked="" type="checkbox"/> Yes <input type="checkbox"/> No	Managing Shop/Area MINOR & PLANNED PROJECT
New Funding Request* <input type="checkbox"/> Yes <input type="checkbox"/> No	Add Funding to Project #
Project Description/Scope (<i>attach any estimate prior to request</i>): RECENT RAINS HAVE FOUND WATER LEAKING INTO THE LAW CENTER COMPLEX LIBRARY. THE SCOPE OF WORK TO WET GLAZE ALL SKYLIGHTS AND SEAL WITH BACKER ROD MATERIALS AND REPLACE THE EXTERIOR VERTICAL CONTROL JOINTS ALONG THE PERIMETER OF THE SKYLIGHTS LOCATIONS.

RE: Law Building Skylight repairs

TU 1 EMERGENCY LEAK REPAIRS

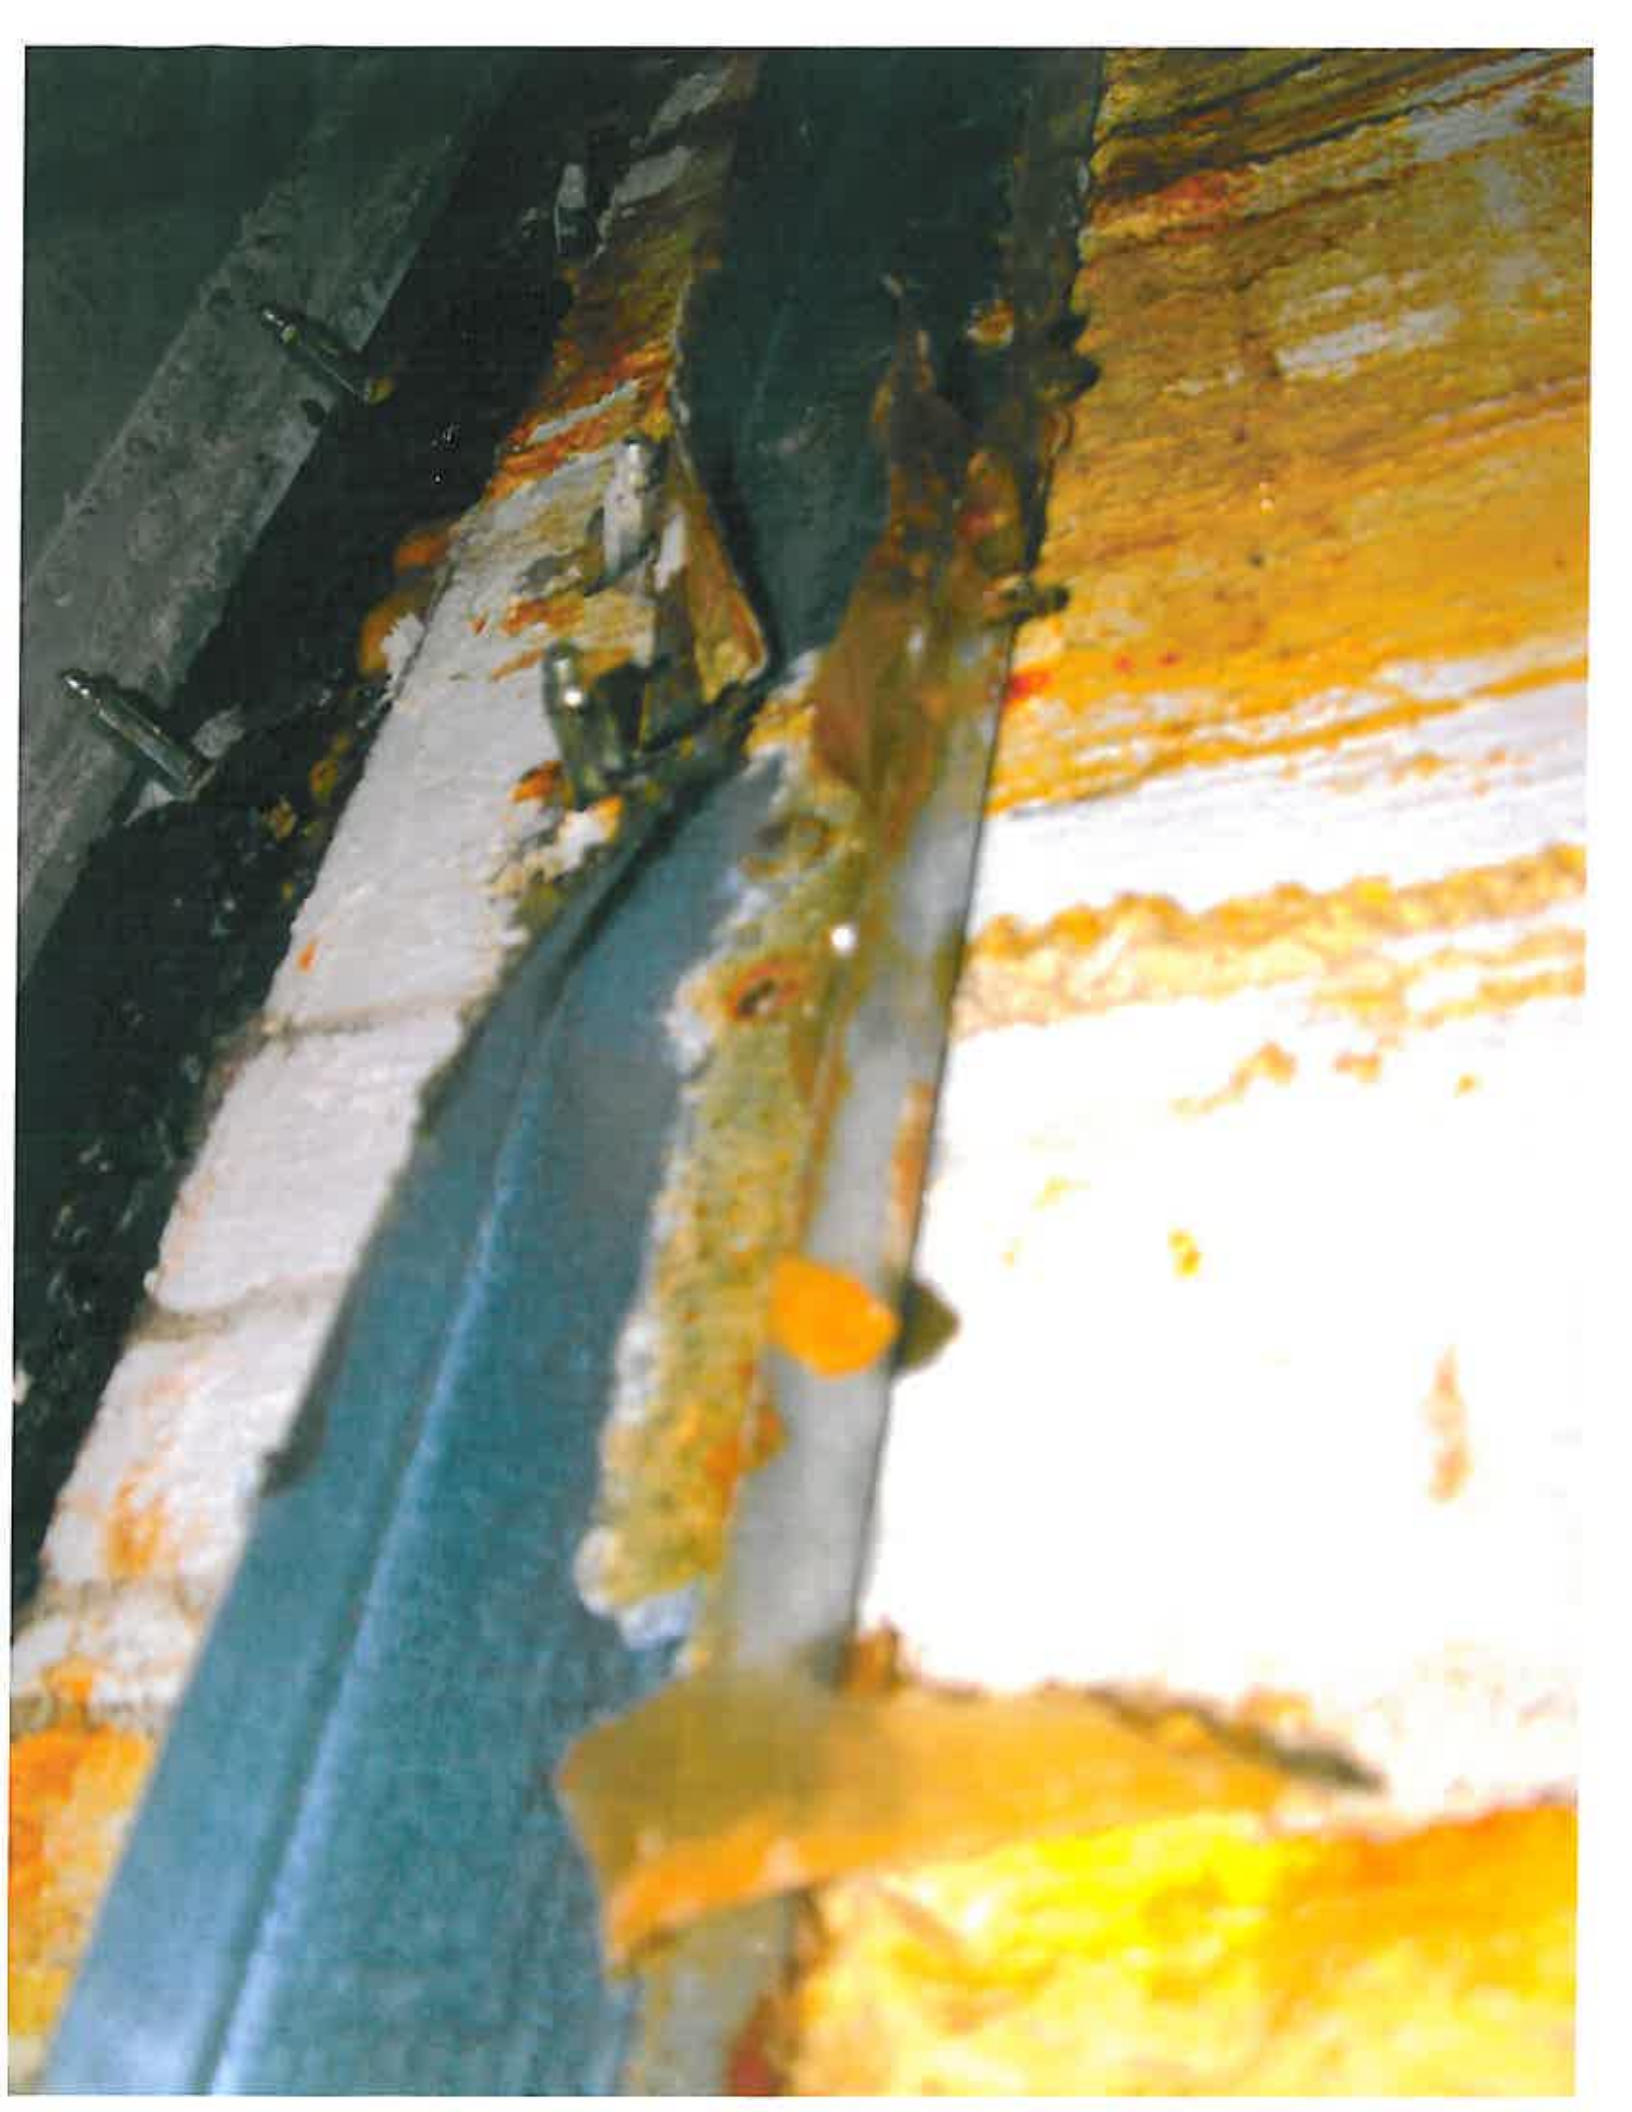
Some more new leaks. This is from yesterday's light rain. I hate to think what will happen if we get a real storm with several inches of rain.
