UNIVERSITY OF HOUSTON

Facility Condition Assessment

Brazos Hall

Inspected February 10, 2022

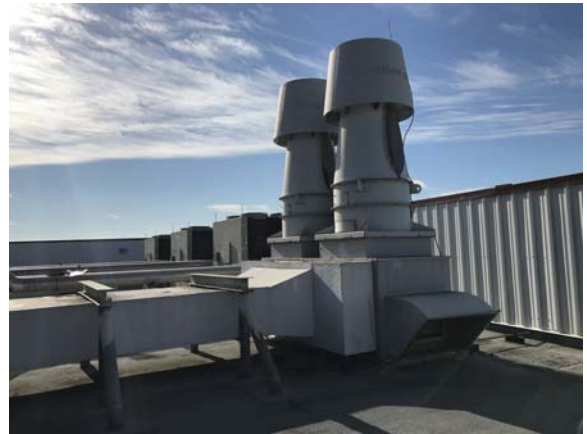
121001a 2/10/2022
Modified bitumen roofing
Main roof

The exterior finishes include standard brick and corrugated metal siding. Both are in good condition and should outlast the ten-year scope of this report. The modified bituminous roofing is in poor condition and should be scheduled for replacement in the near term. The roof has a complete lightning protection system installed. The aluminum-framed, double-pane windows and aluminum and glass storefront system at the main entrance are all in good condition with no recommendations.
