**UNIVERSITY OF HOUSTON**  
**Campus Facilities Planning Committee**  
**Agenda Item Description Form**  
**1/11/13**

- 1. Item:** *Cameron Temporary Emergency Flue Pipe Routing*
- 2. Requesting Department:** *Minor Planned Projects (MPP)*
- 3. Contact Names & Phone Numbers:** *David Laws – 3-9262*
- 4. Presenter:** *Sameer Kapileshwari*
- 5. Recommendation/Action Requested:** *It is recommended to move forward with this temporary flue pipe routing for safety and long term code compliance concerns*

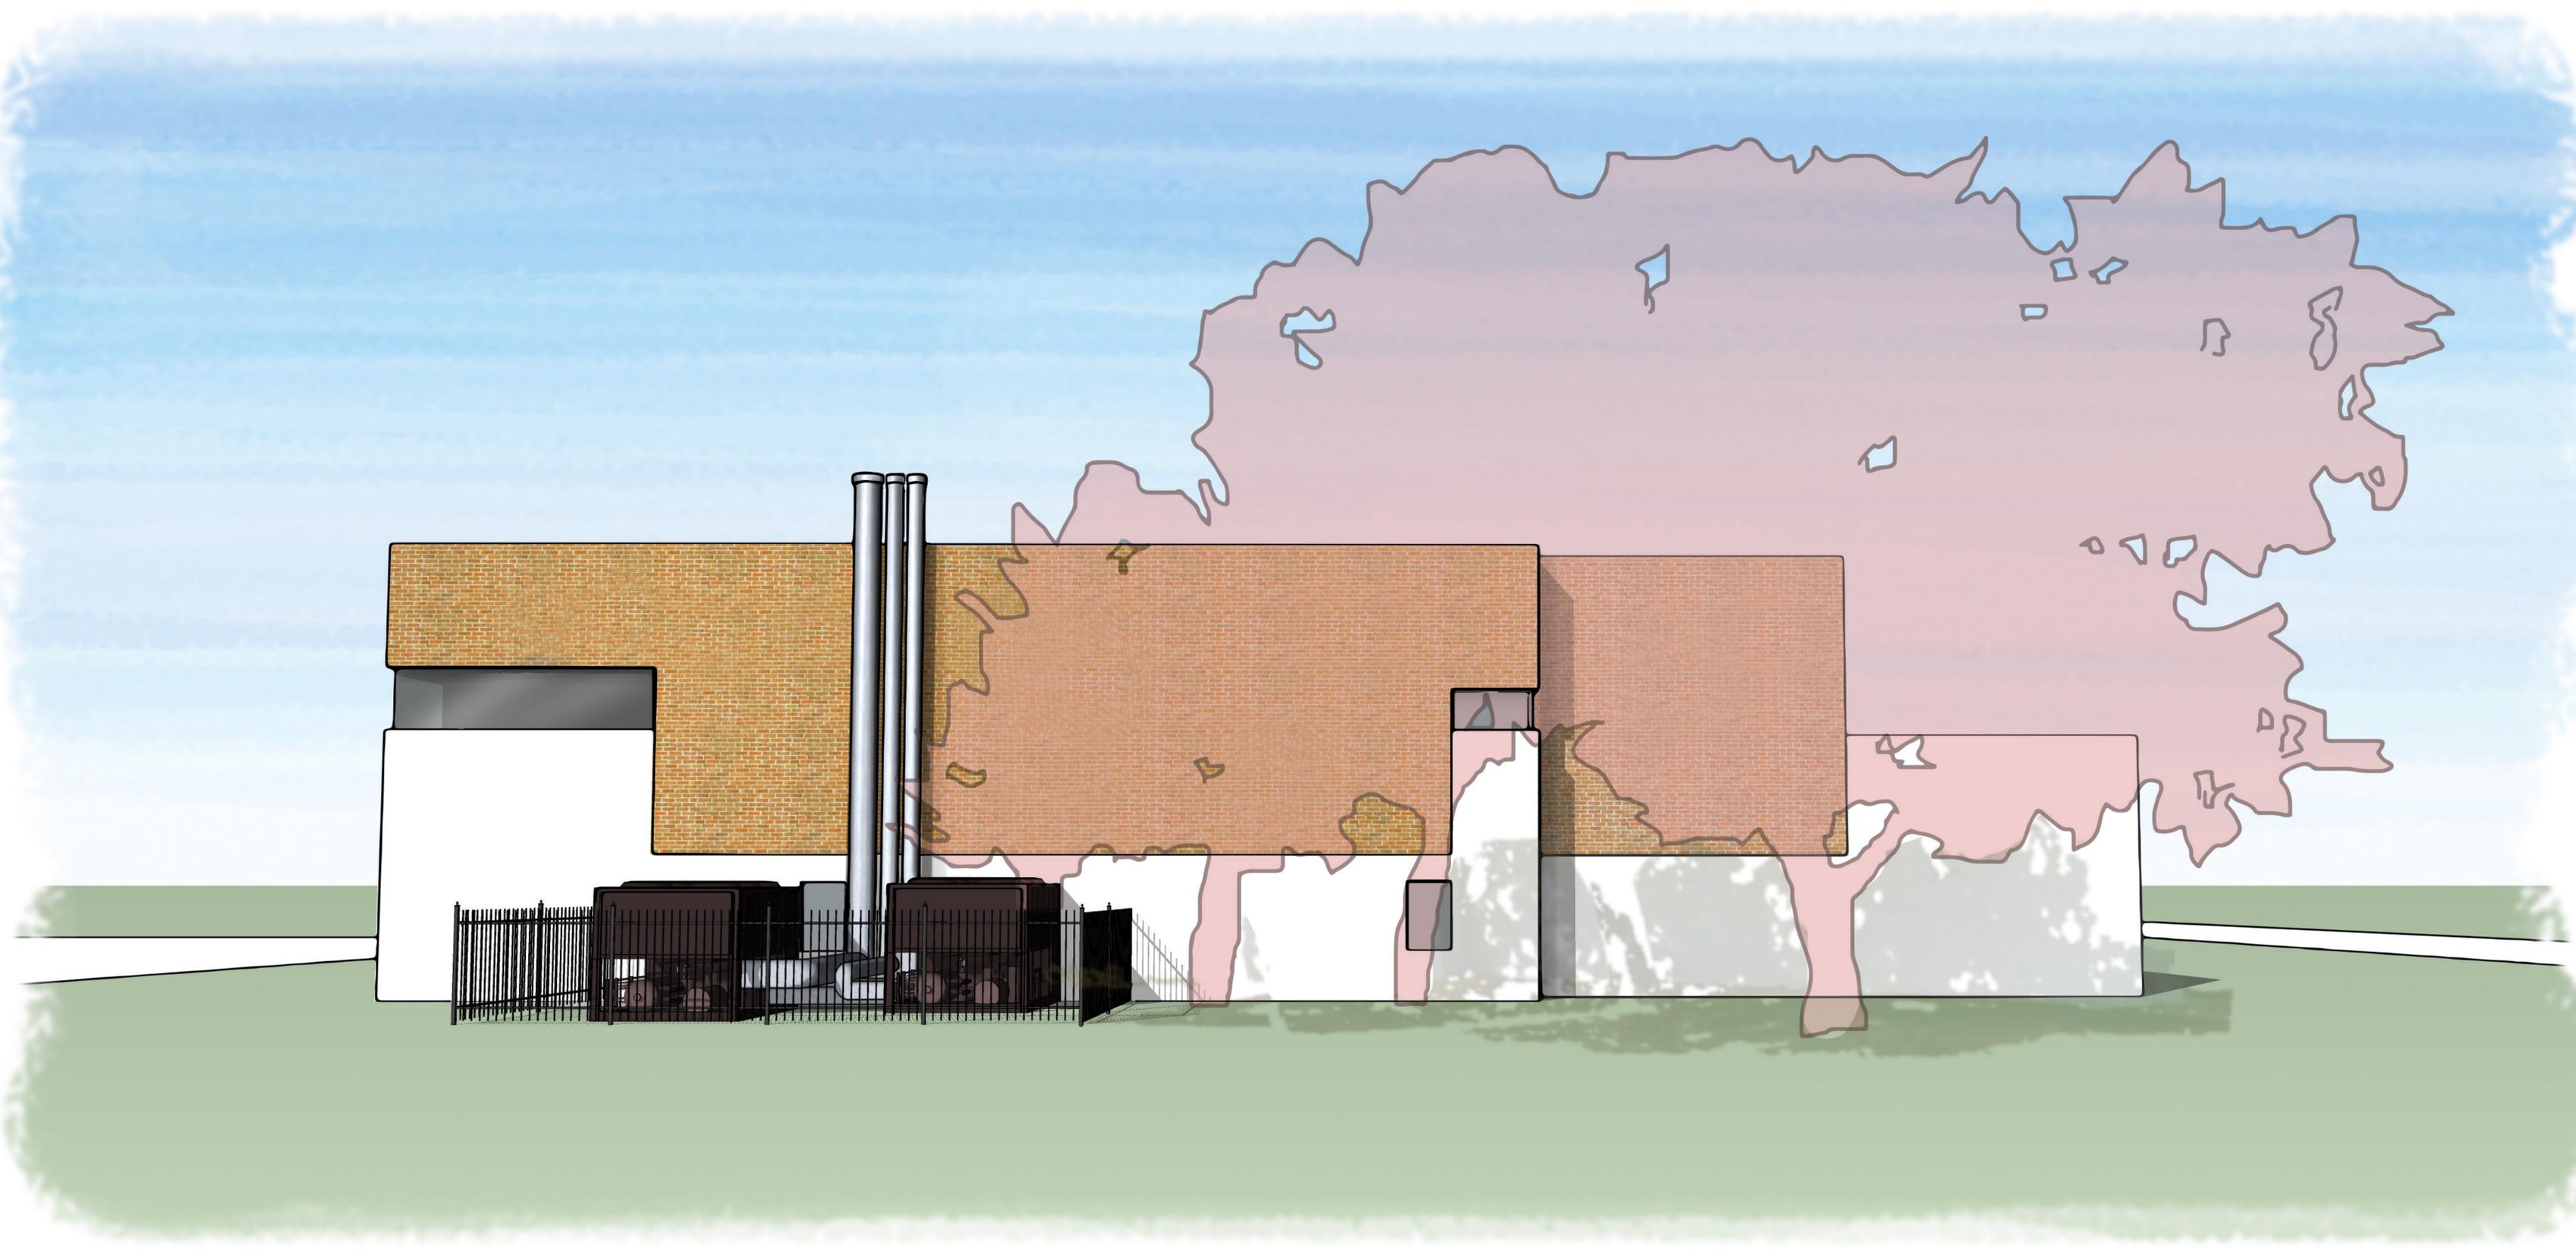
The Temporary Flue Routing Project consists of securing three (3) individual flue vents attached to the external brick veneer. The three (3) stacks will be 6", 10" and 16" respectively. The immediate installation of these flue pipes will alleviate any concerns regarding flue gases from escaping into the building. The external flue pipes will extend four (4) feet above parapet wall and will be secured to the structure by anchor bolts and angle iron. Flue pipe will be insulated in an aluminum jacket.

Please refer to attached rendering of proposed flue pipe routing

- Boiler flue, domestic water and emergency generator exhaust are manifold together into a 20" flue running in a return air chase up to the roof. Flue and/or exhaust gases are not properly isolated per NFPA 54-12.4.5 and NFPA 90A-5.3.4.5., nor is the flue contained within a fire rated enclosure. The intent of the NFPA is to restrict combining of exhaust gases into one common flue to prevent back flow of gases into mechanical room. There is not any backflow preventers currently installed.
- Existing 20" common flue is currently installed exposed in the AHU return air plenum. This flue pipe has reached the end of its useful life and needs to be replaced. If flue appears to have minor breaches and flue gasses may be mixing in the AHU return air chase and circulated back into the building.
